<b>Subject:</b> <b>POPPING NOISE FROM RADIO WHEN PASSING OVER BUMPS</b>	<b>Bulletin No:</b> 09-011/07
	<b>Last Issued:</b> 3/28/2007

2006-2007 MX-5 vehicles with VIN from JM1 NC\*\*\*\* \*\* 100288 to 116742 (produced June 20, 2005 to April 8, 2006)

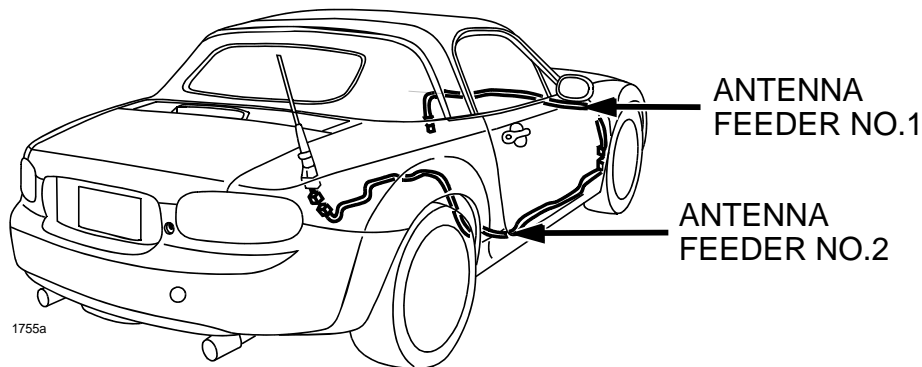
Some vehicles may experience a popping noise from AM radio stations when passing over bumps. This symptom will be present only when AM band is selected.

Due to insufficient crimping, poor contact occurs at antenna feeder connectors 1 and/or 2. As a mass production change, the crimping of the antenna feeder connectors has been revised. Customers having this concern should have their vehicle repaired using the following repair procedure.

1. Verify customer concern.
2. Replace antenna feeders No. 1 and No. 2 with modified ones.
  - For antenna feeder No. 1, refer to ANTENNA FEEDER NO. 1 REPLACEMENT procedure.
  - For antenna feeder No. 2, refer to the appropriate procedure.
    - For soft top equipped models, refer to ANTENNA FEEDER NO. 2 REPLACEMENT - SOFT TOP procedure.
    - For retractable hard top equipped models, refer to ANTENNA FEEDER NO. 2 REPLACEMENT - POWER RETRACTABLE HARD TOP procedure.

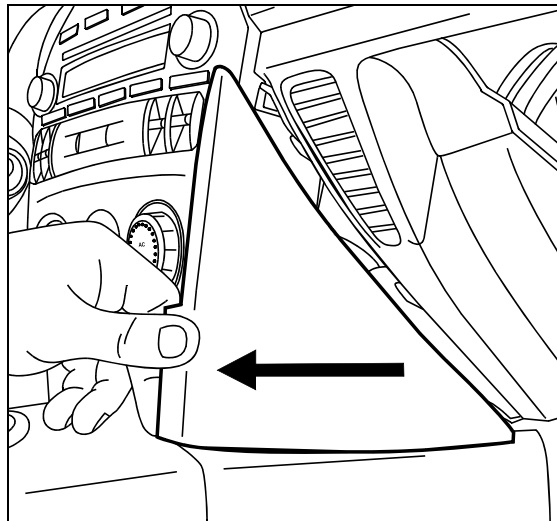
1755b

**PULL SIDE WALL REARWARD  
TO REMOVE**

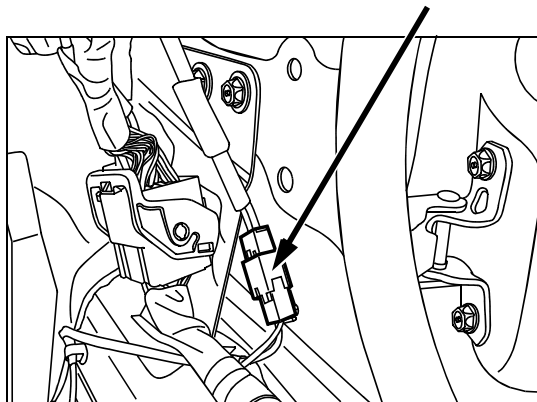
1755c

**DISCONNECT ANTENNA  
FEEDER NO. 1 CONNECTOR  
LOCATED BEHIND PASSENGER  
FRONT SIDE TRIM**

- Disconnect antenna feeder No. 1 connector located behind passenger front side trim (kick panel) before removing dashboard.

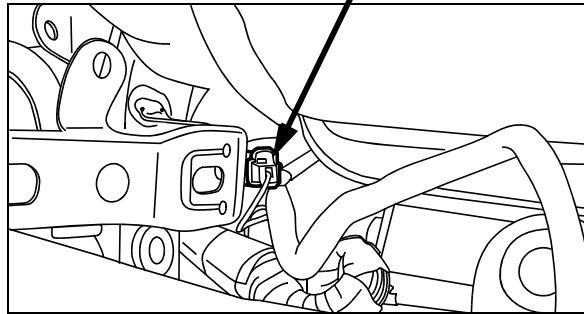
DISCONNECT ANTENNA  
FEEDER NO. 1 CONNECTOR  
LOCATED THROUGH CENTER  
PANEL OPENING

2. Disconnect antenna feeder No. 1 connector through center panel opening.

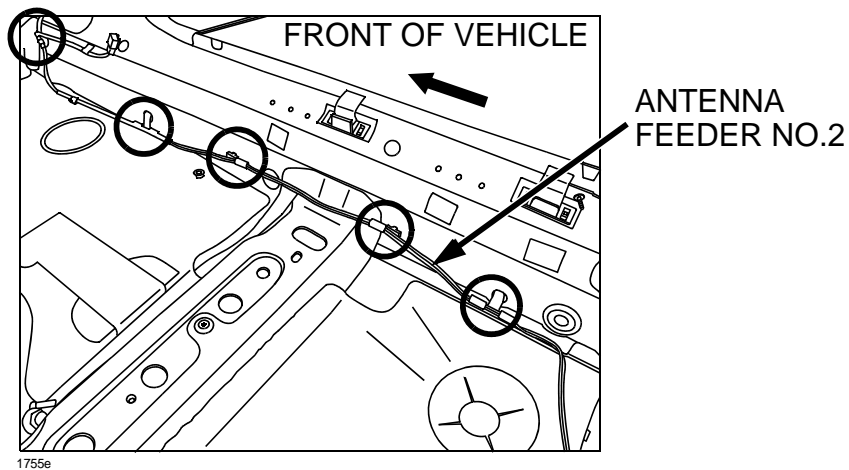
ANTENNA FEEDER NO. 2 ROUTING ALONG PASSENGER SILL - SHOWN CARPET REMOVED.

4. Remove 3 carpet retaining clips along the passenger sill. Fold back carpet to expose antenna feeder No. 2 attachment points along side of vehicle.

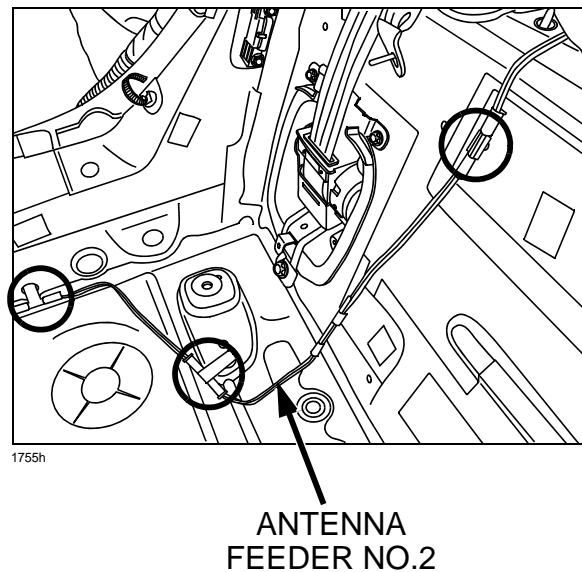
ANTENNA FEEDER NO. 2 ROUTING AT REAR OF PASSENGER COMPARTMENT - SHOWN WITH CARPET AND BACK TRIM REMOVED.

5. Disconnect antenna feeder No. 2 attachment points going through rear of vehicle.

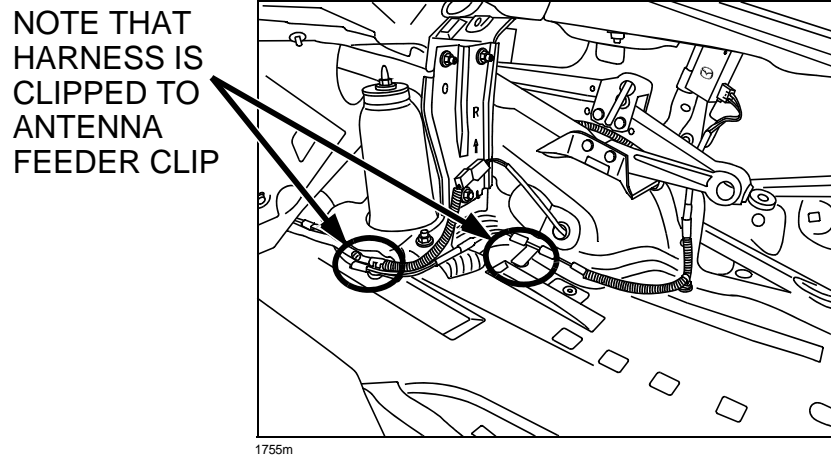
ANTENNA FEEDER NO. 2 TRUNK ROUTING SHOWN WITH SIDE TRIM REMOVED AND CARPET PULLED BACK

8. Remove old antenna feeder No. 2 from vehicle.
9. Route new antenna feeder No. 2 through vehicle same as existing antenna feeder. Install new antenna feeder clips to vehicle as old antenna feeder and clips are removed.

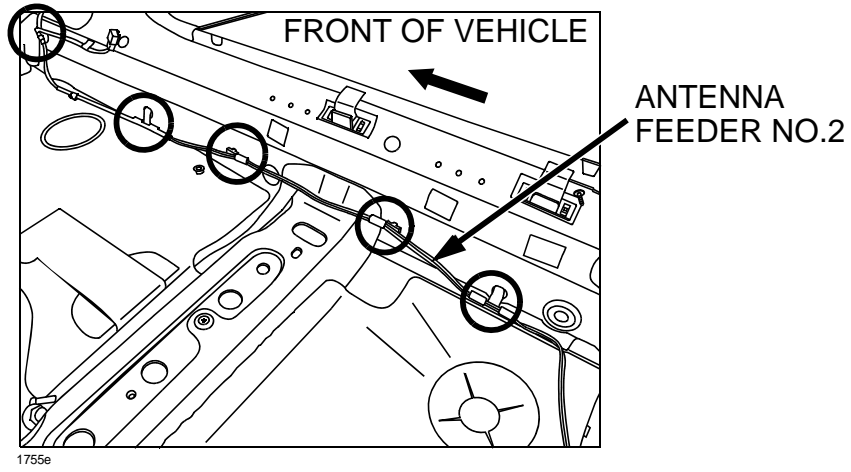
ANTENNA FEEDER NO. 2 ROUTING ALONG PASSENGER SILL - SHOWN CARPET REMOVED.

3. Remove 3 carpet retaining clips along the passenger sill. Fold back carpet to expose antenna feeder No. 2 attachment points.

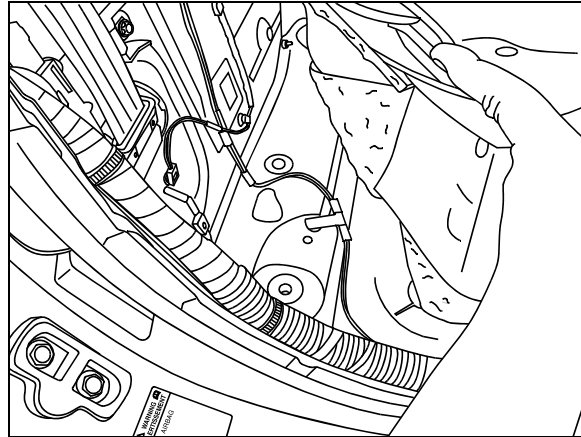
1755g

**CAREFULLY PULL OUT BACK TRIM  
AND FOLD BACK CARPET TO ACCESS  
ANTENNA FEEDER NO. 2**

- Carefully pull back trim out and fold back carpet enough to expose antenna feeder No. 2 attachment points.

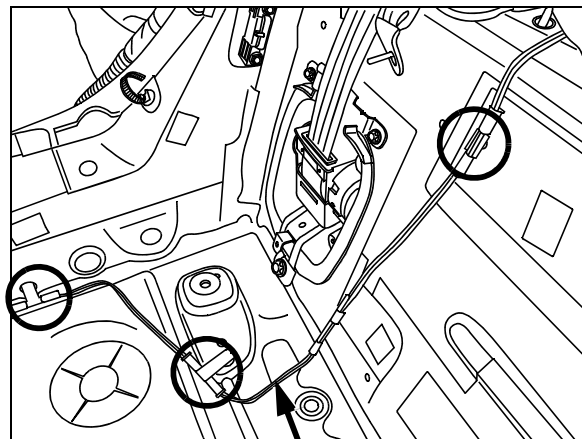
1755h

**ANTENNA FEEDER NO. 2 ROUTING AT REAR  
OF PASSENGER COMPARTMENT - SHOWN  
WITH CARPET AND BACK TRIM REMOVED.**

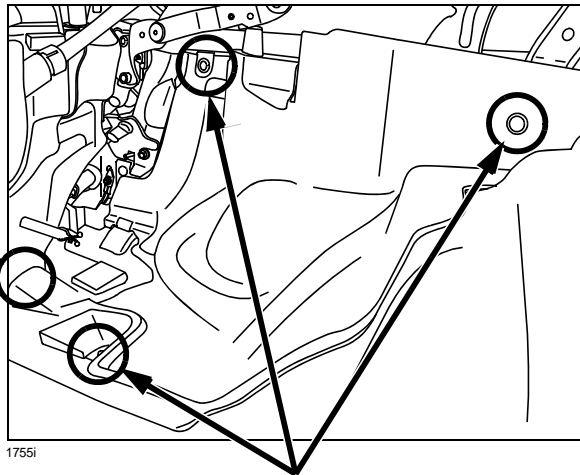
THIS FASTENER  
WILL NEED TO BE  
REMOVED FROM  
THE FRONT, BEHIND  
THE BACK TRIM

REMOVE THESE 3 FASTENERS  
FROM THE TOP

7. Remove 4 retaining fasteners and passenger side rear side shelf. Fold back carpet enough to expose antenna feeder No. 2 attachment points.

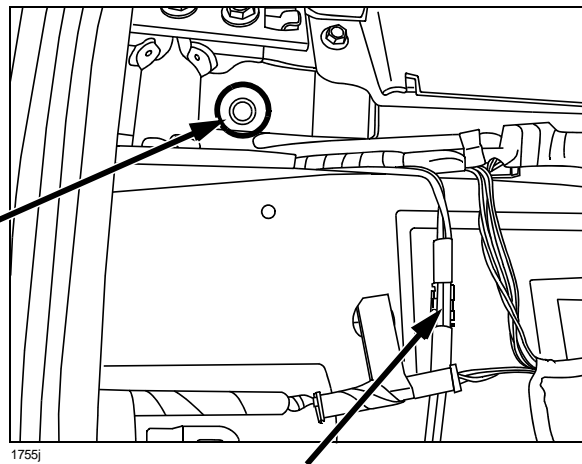
HIDDEN FASTENER  
FOR REAR SIDE TRIM

ANTENNA FEEDER NO. 2  
LOCATED BEHIND BACK TRIM

- 1 fastener is hidden and located behind the back trim, near the antenna feeder.

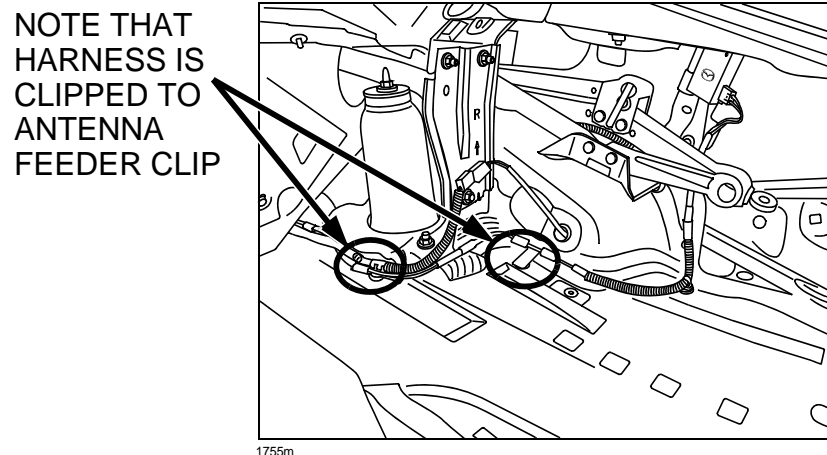
ANTENNA FEEDER NO. 2 TRUNK ROUTING  
SHOWN WITH SIDE TRIM REMOVED AND  
CARPET PULLED BACK

12. Route new antenna feeder No. 2 through vehicle same as existing antenna feeder. Install new antenna feeder clips to vehicle as old antenna feeder and clips are removed.
