| Subject: POWER RETRACTABLE HARDTOP - DIFFICULT TO OPEN / CRUNCH NOISE WHEN OPENING | Bulletin No: 09-038/07 |
| | Last Issued: 11/15/2007 |

2007 MX-5 vehicles equipped with Power Retractable Hardtop and VINs lower than JM1 NC**** ** 142750 (built before September 1, 2007)

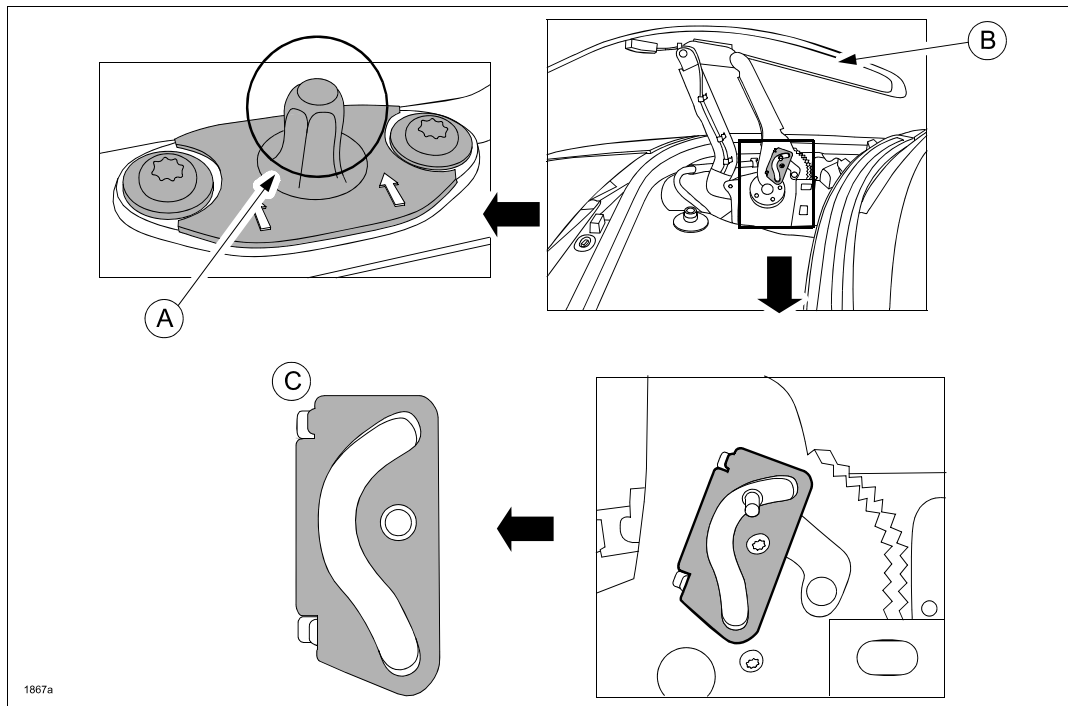
Some vehicles may experience that when trying to open (lower) the Power Retractable Hardtop (RHT), the RHT exhibits a crunching noise and has difficulty opening from the fully closed (up) position.

The clearance between the male wedge (A) on the vehicle body and the receiver on the deck (B) is too tight. As a mass-production change, the shape of the male wedge (A) has been changed. Customers having this concern should have their vehicle repaired using the following repair procedure. The male wedge (A) and both left and right cam plates (C) will need to be replaced.
