Service Information

Category S	Repair Guidance	Ref. No. R017/16C	Page 1 of 7
Coverage <input type="checkbox"/> Distributor only <input checked="" type="checkbox"/> Please inform your dealers		Date Issued February 26, 2016	
Please convey this information to your <input checked="" type="checkbox"/> Warranty Dept. <input checked="" type="checkbox"/> Parts Dept. <input type="checkbox"/> Directing Dept. <input type="checkbox"/> Training Dept. <input type="checkbox"/> General Manager <input checked="" type="checkbox"/> Field Rep.		Date Revised February 1, 2017	
Applicable Model MX-5 (ND) with INNER CLOTH		Applicable Countries or Specifications Worldwide

Subject: Convertible Top-Inner Cloth Coming Off Causing Poor Appearance and Obstructing View of Back Window

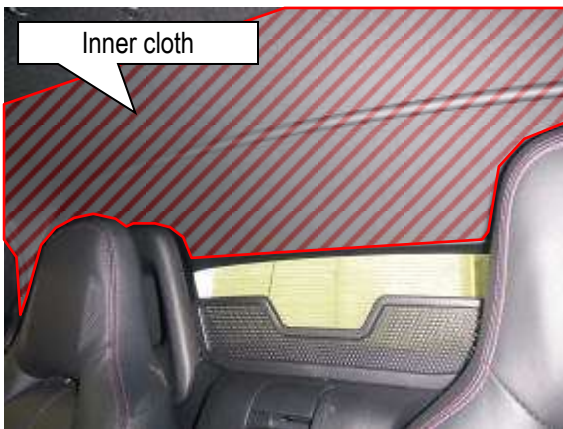
Normal condition

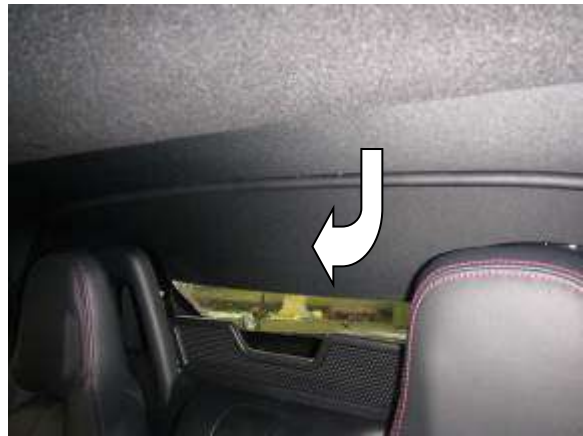
Some vehicles may exhibit a coming off of the inner cloth at the rear end causing poor appearance and obstructing view of the back window.

The coming off occurs when the convertible top is opening and/or closing or by vibration during vehicle driving.

Coming off the inner cloth

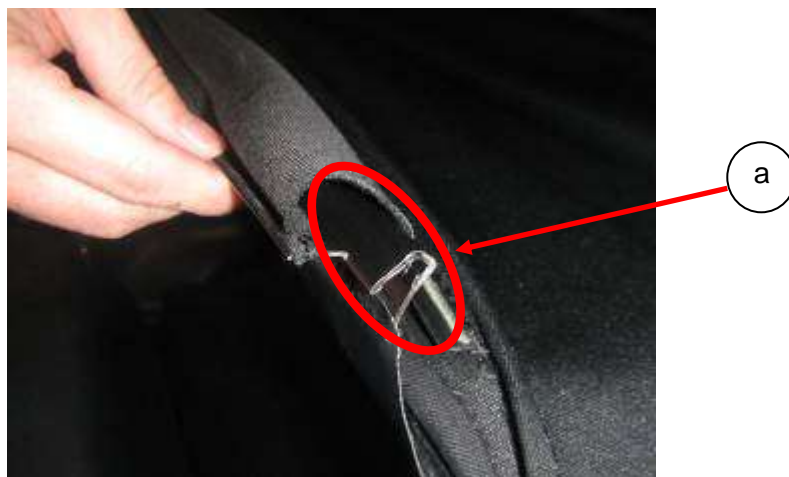
Case A: The J-hook (a) binding to hold the inner cloth becomes loose because of opening/closing the convertible top many times or by heat influence.

Case B: After the previous improvement carried out from January 19, 2016 at the supplier, some of the J-hook has been found that it still becomes loose to bind and hold the inner cloth during the assembly process at the supplier.

Case A: Clips (Two top-protectors) have been additionally installed to the both side edges of the J-hook to prevent opening/loosening the J-hook.

Case B: An improved inspection process has been started at the supplier, which is to check the appearance of the inner cloth after installation of the clip.
