Service Information

0.Category S	Repair Guidance	Ref. No. R041/17	Page 1 of 6
Coverage <input type="checkbox"/> Distributor only <input checked="" type="checkbox"/> Please inform your dealers		Date Issued June 15, 2017	
Please convey this information to your <input type="checkbox"/> Director <input checked="" type="checkbox"/> General Manager <input checked="" type="checkbox"/> Warranty Dept. <input checked="" type="checkbox"/> Parts Dept. <input checked="" type="checkbox"/> Training Dept. <input checked="" type="checkbox"/> Field Rep.		Date Revised	
Applicable Model MX-5 (ND) with Retractable Fastback	Applicable Countries and/or Vehicle Specifications Worldwide

Subject: Wind Noise from Roof when driving

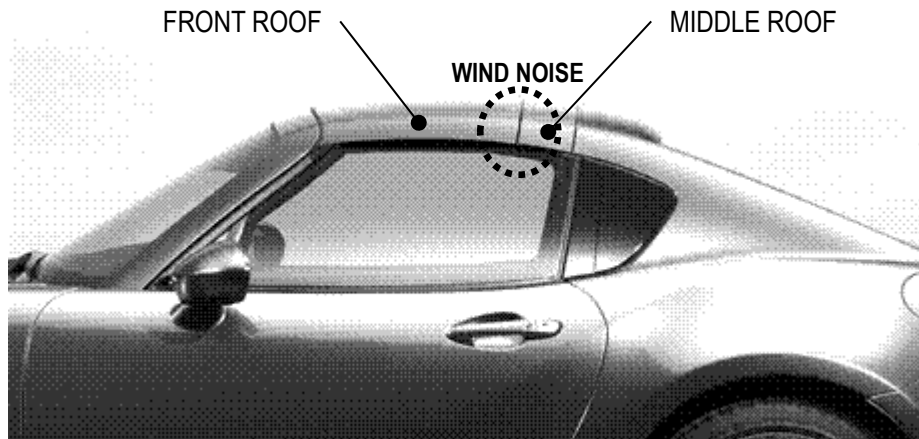
Some vehicles may exhibit a wind noise from the area between the front and middle roofs when driving at speeds over 60 km/h.

Due to parts variation, some vehicles may have a poor sealing between weatherstrips of the front and middle roofs, causing a wind noise.

Urethane foam pads have been installed to the weatherstrips to improve the sealing ability.
