Subject: INTERFERENCE BETWEEN SOFT TOP AND BELTLINE MOLDING	Bulletin No: 09-018/06
	Last Issued: 5/4/2006

APPLICABLE MODEL(S)/VINS

2006 MX-5 vehicles with VINs lower than JM1 NC**** ** 110950 (produced before December 19, 2005)

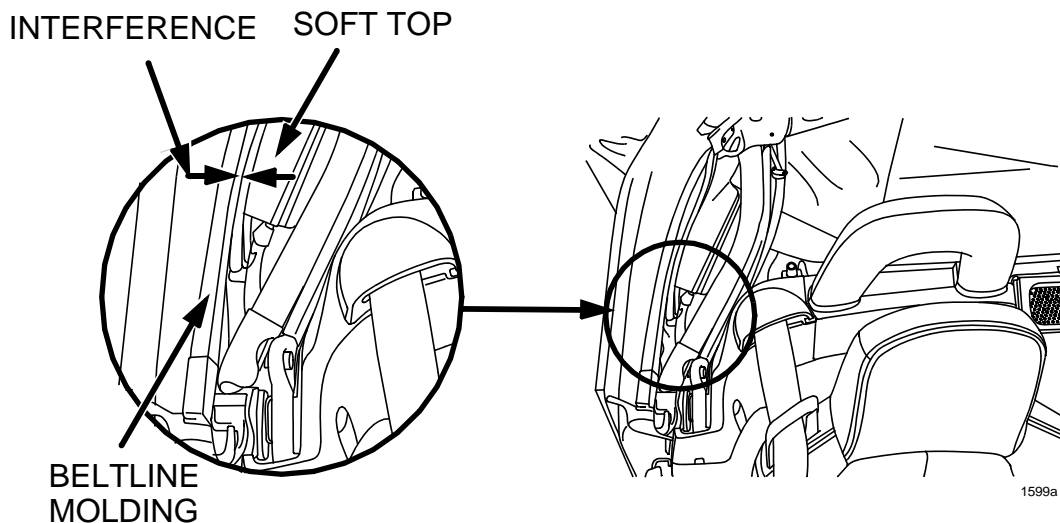
Some vehicles may experience the convertible soft top makes contact with the beltline molding near the door. In some cases, this may cause difficulty in opening and closing of the convertible soft top and may cause damage to the cable end bracket.

As a mass production change, the shape of the cable end bracket has been changed to increase the clearance. Customers having this concern should have their vehicle repaired using the following repair procedure.
