Subject: VARIABLE VALVE TIMING (VVT) NOISE WHEN STARTING ENGINE	Bulletin No: 01-010/11
	Last Issued: 12/21/2011

APPLICABLE MODEL(S)/VINS

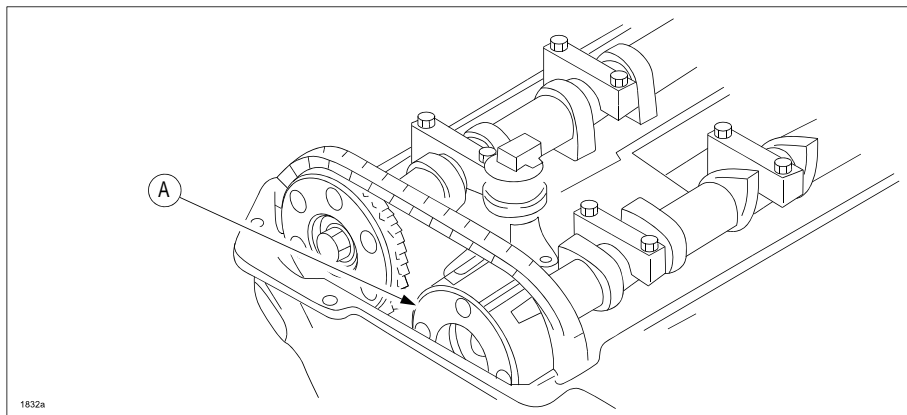
When the engine is first started, some vehicles may exhibit a loud ticking noise from the variable valve timing (VVT) actuator (A). This is caused by the lock pin of the variable valve timing actuator not fully engaging or from a worn lock pin hole. Heat treatment has now been added around the hole of the variable valve timing rotor lock pin to prevent this from happening.

Customers having this concern should have their vehicle repaired using the following repair procedure.

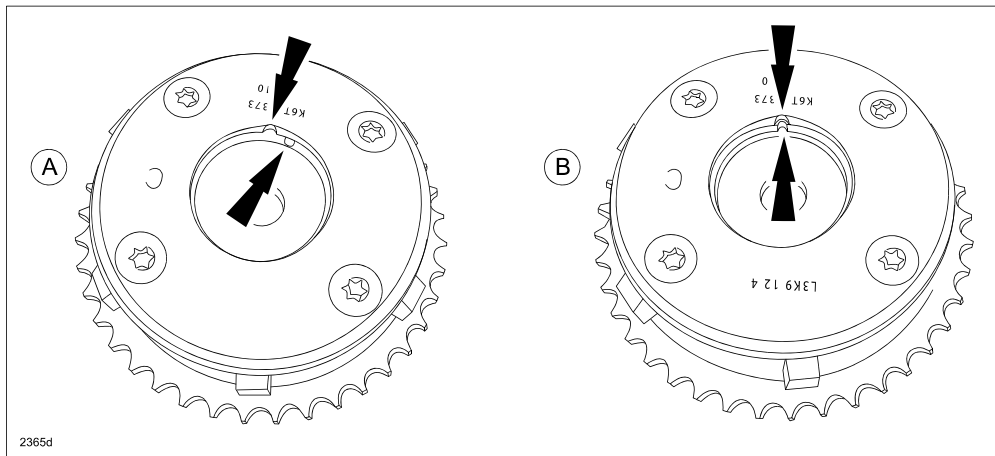
1. Verify customer concern.
2. Write down the customer's radio station presets.
3. After the engine cools down, disconnect the negative battery cable (to prevent DTCs from being stored).
4. Remove the cylinder head cover. See TIMING CHAIN REMOVAL/INSTALLATION [LF/L3] on MS3.
5. Turn the crankshaft clockwise so that the notches on the VVT actuator can be checked.
 - A. If the notches are NOT aligned, go to the next step.
 - B. If the notches are aligned, there is no problem with the VVT actuator and this information is not applicable. Refer to MS3 for troubleshooting.

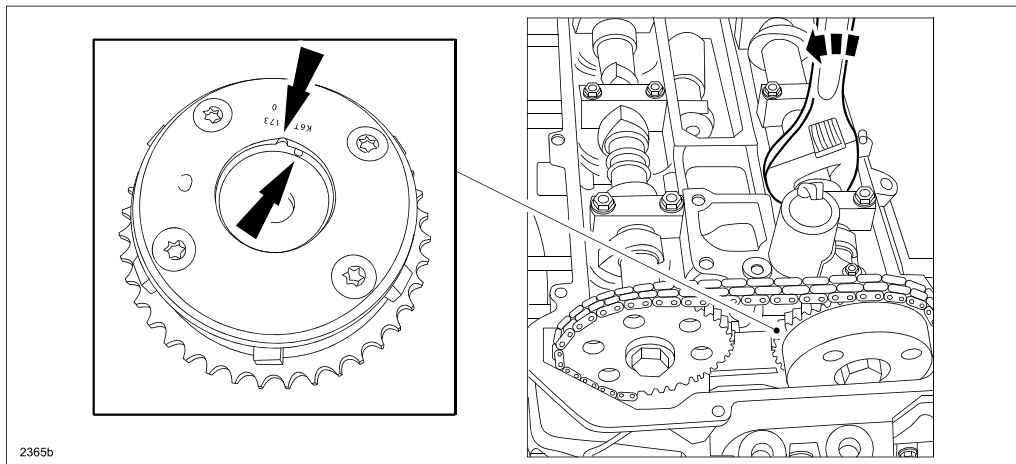
6. Turn the camshaft counterclockwise to align the notches on the VVT actuator.

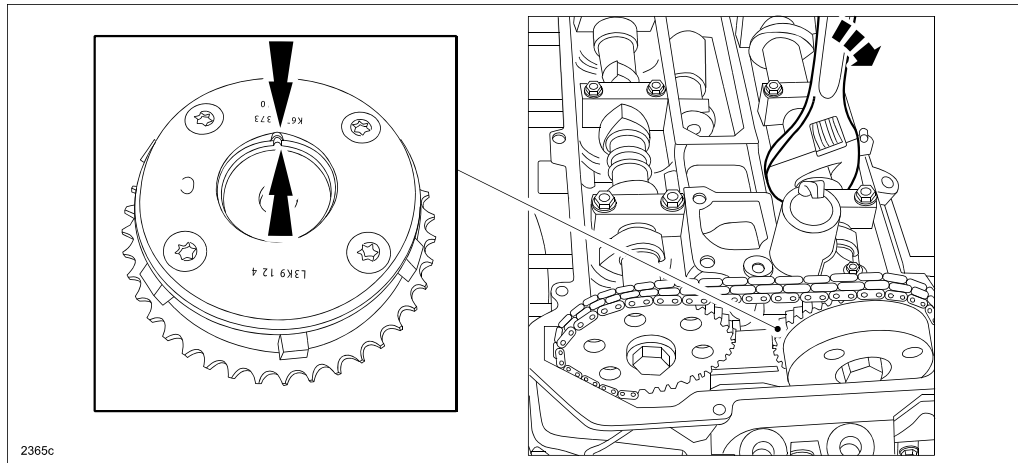
7. With the notches aligned, turn the camshaft clockwise 90 degrees.

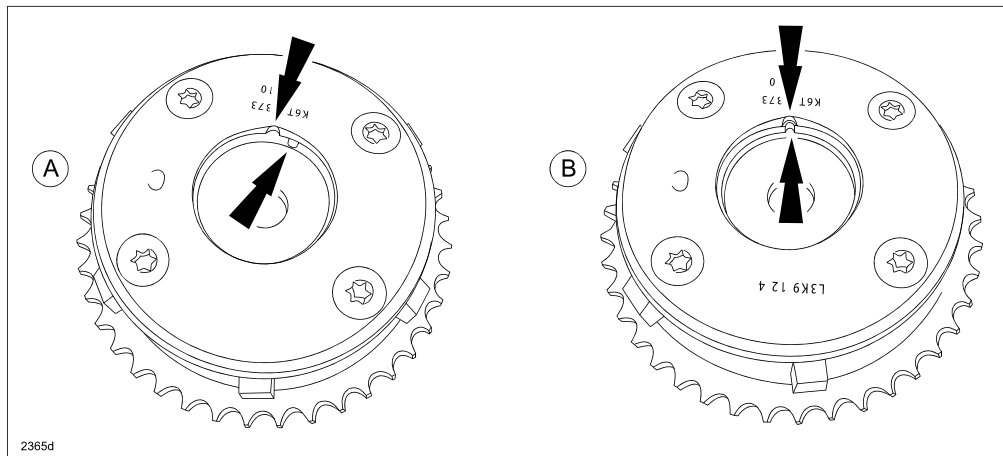
8. Check the notches again.

- A. If the notches are NOT aligned, go to the next step.
- B. If the notches are aligned, there is no problem with the VVT actuator and this information is not applicable. Refer to MS3 for troubleshooting.

9. Replace the VVT actuator.
