Category F (01)	Applicable Model/s 1999 Miata	Subject HARD TO REFUEL	Bulletin No. 007/99
			Issued 04/02/99
			Revised

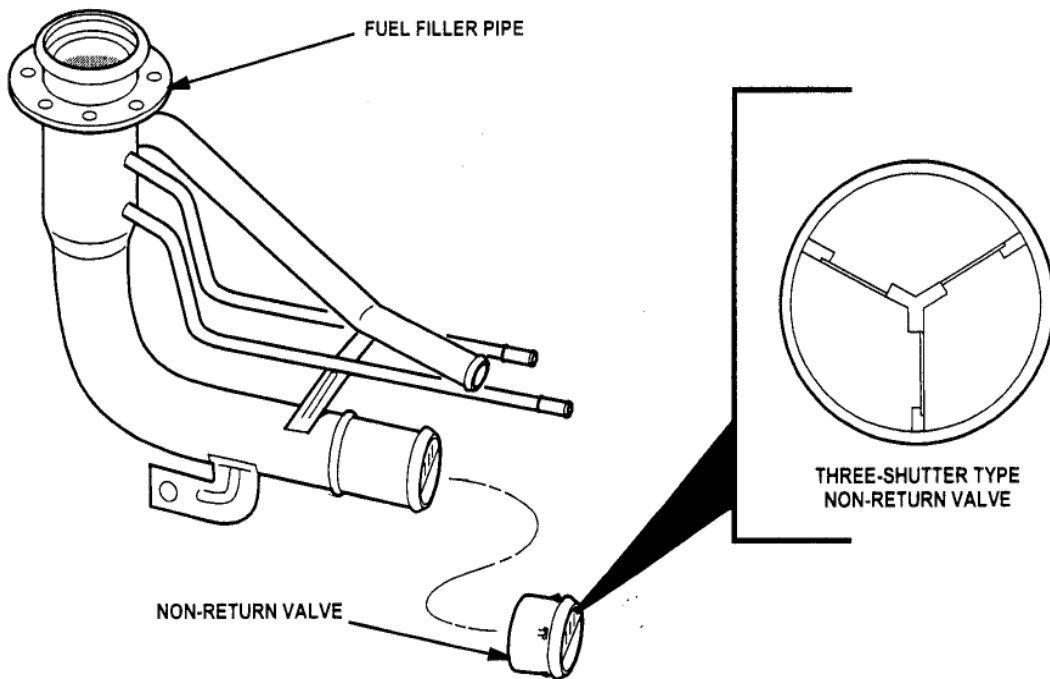
Excessive amount of time is required when refueling the vehicle due to pump nozzle repeatedly shutting off. This may be caused by the non-return valve (one-shutter type) becoming stuck in the closed position. A modified (three-shutter type) non-return valve is now available to resolve this concern.

1. Verify customer concern.
2. Replace the non-return valve with the modified part according to the Workshop Manual (section 01-14).
