## 2006-2013 MX-5

### *MANUAL TRANSMISSION WILL NOT SHIFT*

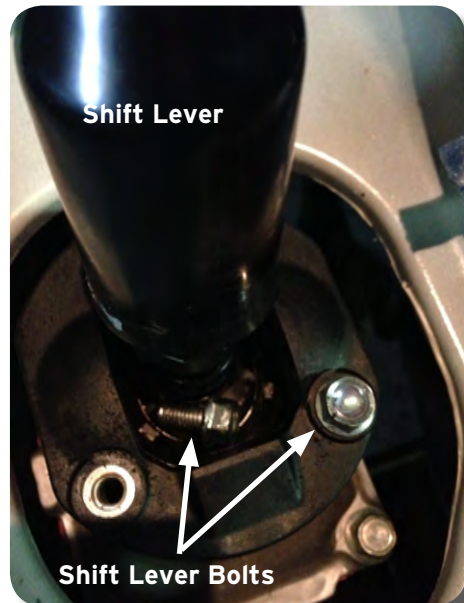
Some vehicles equipped with manual transmission may exhibit a no-shift concern. This may be caused by a shift lever bolt that came loose and lodged in the shifter area.

Re-install the shift lever bolts and torque them to 7.8 - 11 Nm {80 - 110 kgf cm, 69 - 95 in lb} to resolve the customer's concern.
