© 2008 Mazda Motor of America, Inc.

Subject: SQUEAKING NOISE AROUND REAR CENTER CONSOLE LID	Bulletin No: 09-040/08
	Last Issued: 12/12/2008

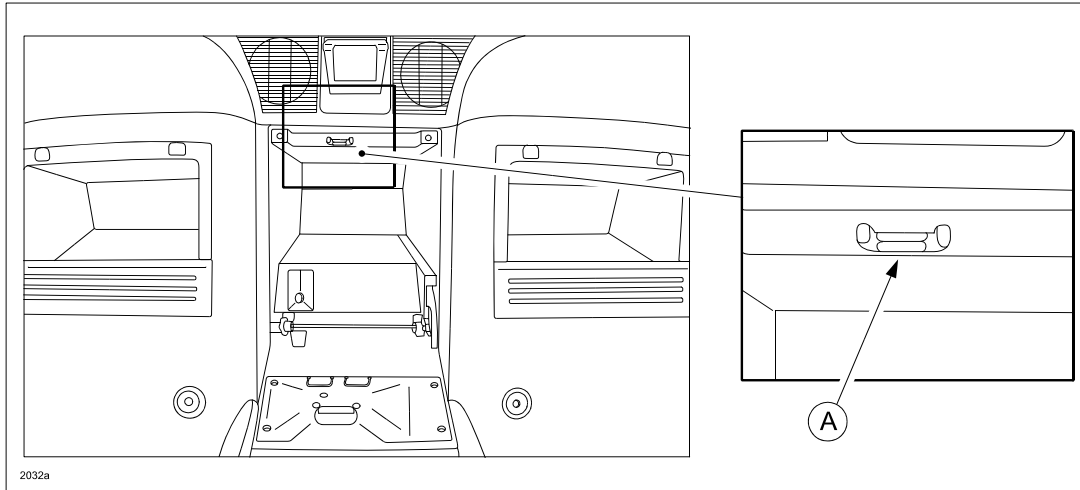
1. Verify customer concern.
2. Open the center rear console lid and grasp the striker to verify if there is any movement of the striker.
 - If there is movement, go to STEP 3.
 - If there is no movement, continue to diagnose source of squeak.
