# Technical Service Bulletin

<b>Subject:</b> <b>AIR CONDITIONER DOES NOT BLOW COLD AIR DUE TO CRACKED COOLER PIPE (HI) A (REFRIGERANT LEAK)</b>	<b>Bulletin No.:</b> 07-002/21
	<b>Last Issued:</b> 02/01/2021

2016-2020 MX-5 with VINs lower than JM1ND\*\*\*\*\*418386 (built before Sep. 10, 2020)

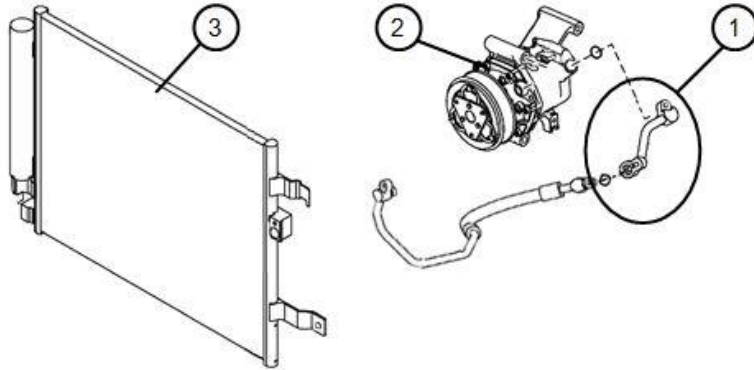
Some vehicles may experience that the A/C does not blow cold air (blows warm air) due to a refrigerant leak. This is caused by a crack in the cooler pipe (HI) A (1) due to engine vibration. To correct this issue, the material and thickness of the cooler pipe (HI) A has been changed to increase durability (pipe diameter has been changed from 12mm to 16mm).

(1)	Cooler pipe (HI) A
(2)	A/C compressor
(3)	Condenser

- If the cooler pipe (HI) A is cracked, replace the cooler pipe (HI) A with a modified one according to the instructions on MGSS (REFRIGERANT LINE REMOVAL/INSTALLATION).
- If the cooler pipe (HI) A is not cracked, this TSB is not applicable. Refer to troubleshooting procedure on MGSS (NO COOL AIR [CLIMATE CONTROL SYSTEM]).

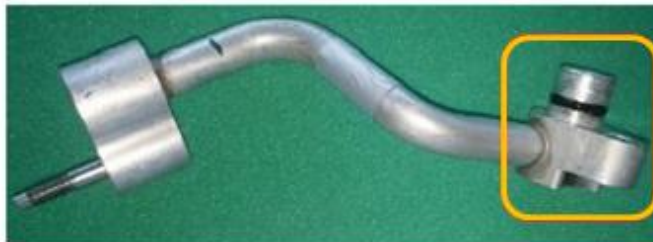
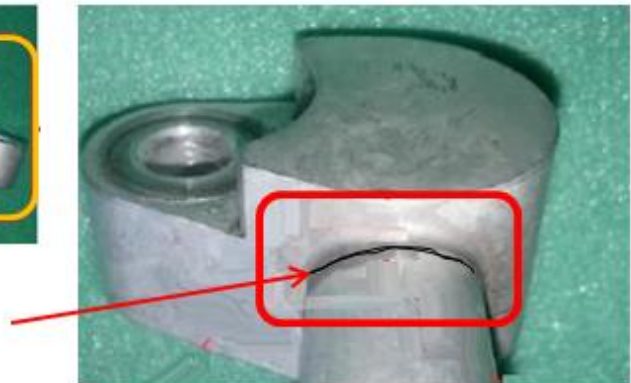
Location of cracking
