Service Information

0.Category S	Repair Guidance	Ref. No. R058/17	Page 1 of 2
Coverage <input type="checkbox"/> Distributor only <input checked="" type="checkbox"/> Please inform your dealers		Date Issued August 3, 2017	
Please convey this information to your <input type="checkbox"/> Director <input checked="" type="checkbox"/> General Manager <input checked="" type="checkbox"/> Warranty Dept. <input checked="" type="checkbox"/> Parts Dept. <input checked="" type="checkbox"/> Training Dept. <input checked="" type="checkbox"/> Field Rep.		Date Revised	
Applicable Model MX-5 (ND) with Retractable Fastback		Applicable Countries and/or Vehicle Specifications Worldwide

Subject: Middle Headliner looks loose

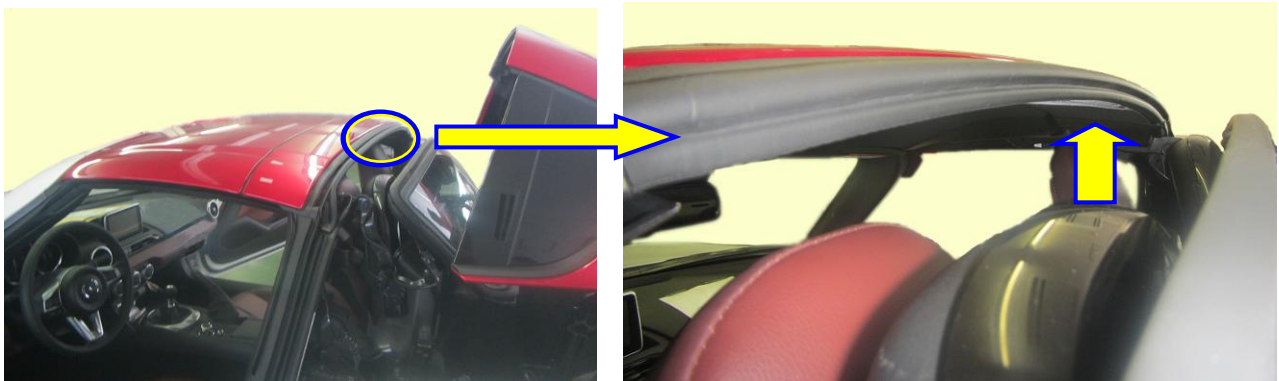
Some customers may complain that middle headliner looks loose at the center rear end.

Due to parts variation, the middle headliner may look loose at the center rear end.

When you receive a customer complaint on this concern, install an additional fastener.
