<b>Subject:</b> <b>POPPING NOISE FROM RADIO WHEN PASSING OVER BUMPS</b>	<b>Bulletin No:</b> 09-011/07
	<b>Last Issued:</b> 3/28/2007

2006-2007 MX-5 vehicles with VIN from JM1 NC\*\*\*\* \*\* 100288 to 116742 (produced June 20, 2005 to April 8, 2006)

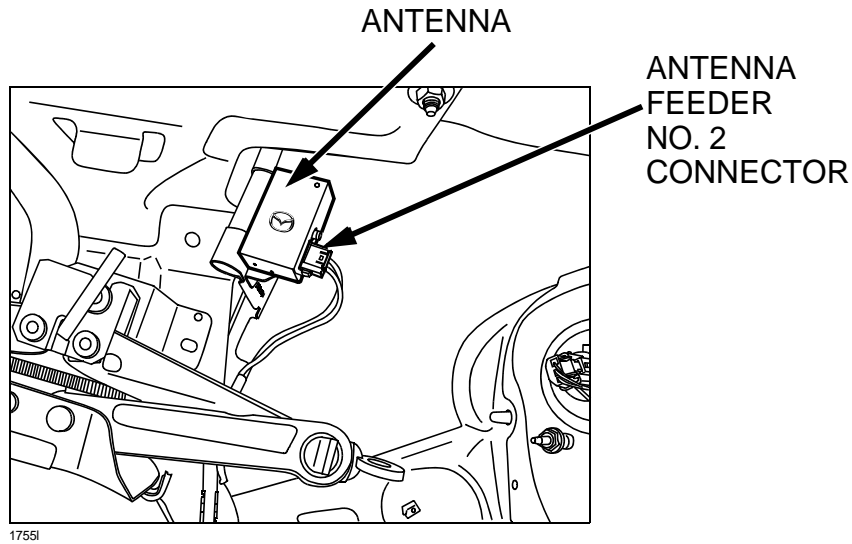
7. Disconnect antenna feeder No. 2 from antenna.

8. Remove old antenna feeder No. 2 from vehicle.
9. Route new antenna feeder No. 2 through vehicle same as existing antenna feeder. Install new antenna feeder clips to vehicle as old antenna feeder and clips are removed.

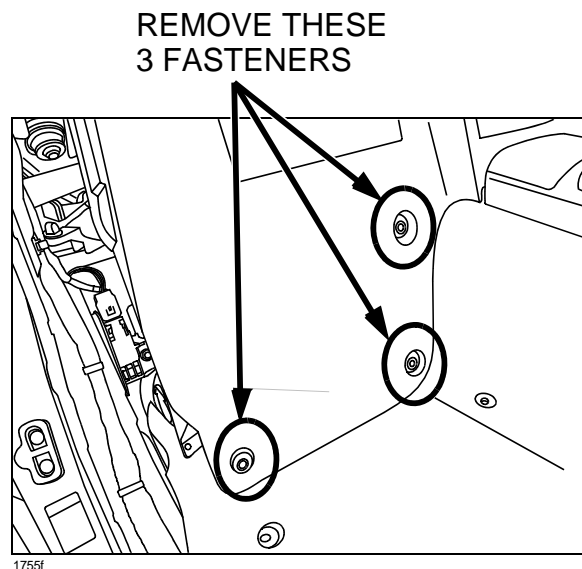
4. Remove 3 fasteners located on back trim as indicated.

- Carefully pull back trim out and fold back carpet enough to expose antenna feeder No. 2 attachment points.

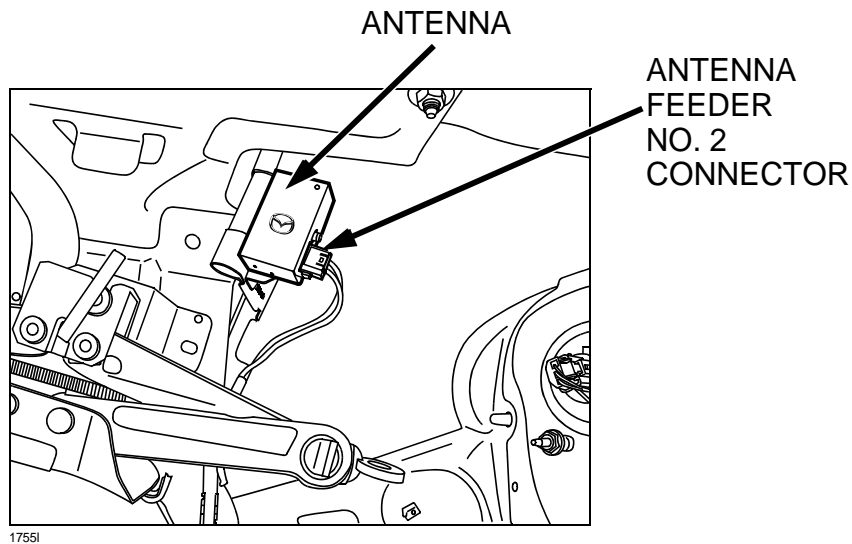
10. Disconnect antenna feeder No. 2 from antenna.

11. Remove old antenna feeder No. 2 from vehicle.

12. Route new antenna feeder No. 2 through vehicle same as existing antenna feeder. Install new antenna feeder clips to vehicle as old antenna feeder and clips are removed.
