Service Information

Category S	Repair Guidance	Ref. No. R017/16C	Page 1 of 7
Coverage <input type="checkbox"/> Distributor only <input checked="" type="checkbox"/> Please inform your dealers		Date Issued February 26, 2016	
Please convey this information to your <input checked="" type="checkbox"/> Warranty Dept. <input checked="" type="checkbox"/> Parts Dept. <input type="checkbox"/> Directing Dept. <input type="checkbox"/> Training Dept. <input type="checkbox"/> General Manager <input checked="" type="checkbox"/> Field Rep.		Date Revised February 1, 2017	
Applicable Model MX-5 (ND) with INNER CLOTH		Applicable Countries or Specifications Worldwide

Subject: Convertible Top-Inner Cloth Coming Off Causing Poor Appearance and Obstructing View of Back Window

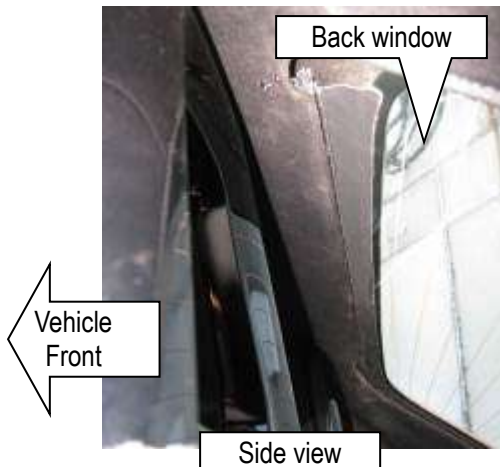
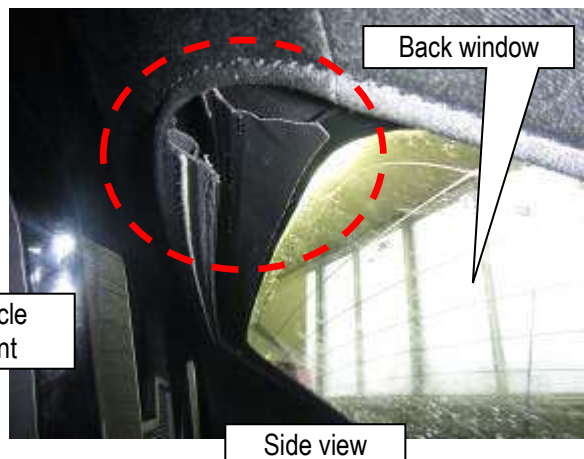
Some vehicles may exhibit a coming off of the inner cloth at the rear end causing poor appearance and obstructing view of the back window.

The coming off occurs when the convertible top is opening and/or closing or by vibration during vehicle driving.

Case A: The J-hook (a) binding to hold the inner cloth becomes loose because of opening/closing the convertible top many times or by heat influence.

Case B: After the previous improvement carried out from January 19, 2016 at the supplier, some of the J-hook has been found that it still becomes loose to bind and hold the inner cloth during the assembly process at the supplier.

Case A: Clips (Two top-protectors) have been additionally installed to the both side edges of the J-hook to prevent opening/loosening the J-hook.

Case B: An improved inspection process has been started at the supplier, which is to check the appearance of the inner cloth after installation of the clip.
